### AGENDA

### STATE BUILDING CODE TECHNICAL REVIEW BOARD

In Re: A10 Capital LLC Appeal No. 24-05

1. On February 20, 2024, the City of Hampton Community Development Department, Property Maintenance and Zoning Enforcement Division (City), the agency responsible for the enforcement of Part III of the 2018 Virginia Uniform Statewide Building Code (VUSBC or VMC), issued a Notice of Violation (NOV) to KRS Holdings (KRS), for the structures located at 2101, 2103, 2105, 2107, 2109, 2111, 2113, 2115, 2117, 2119, and 2121 Kecoughtan Road, in the City of Hampton, for unsafe structure or structure unfit for human occupancy citing VMC Section 106.1 Unsafe Structure or Structures Unfit for Human Occupancy and providing the following:

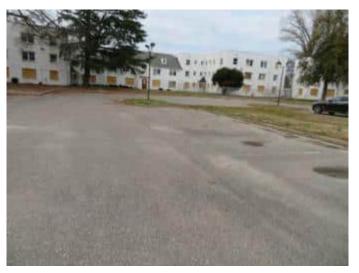
3. Typical condition of asphalt pavement.

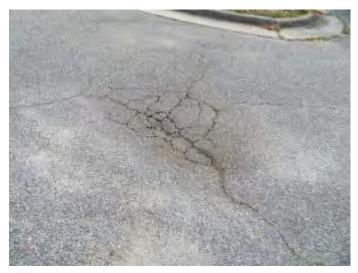
4. Localized asphalt pavement distress.

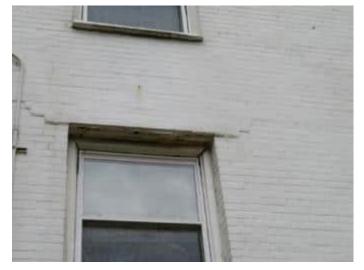
37. Cracking and possible off-plane movement over window.

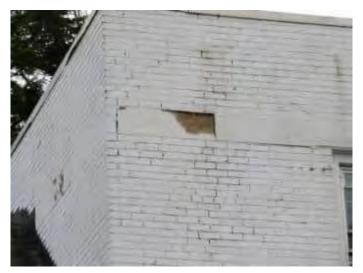
40. Spalling concrete at exterior.

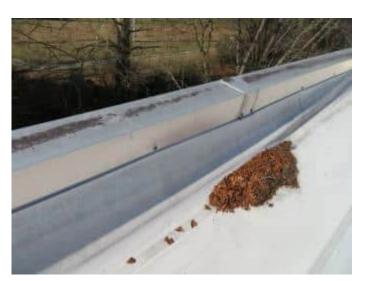
46. Vegetative debris at parapet wall.

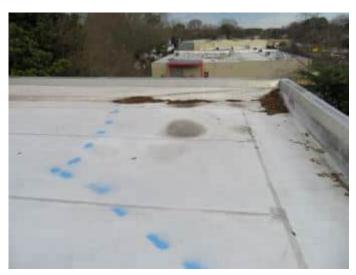
48. Area of possibly damaged roof structure at Building 2115.

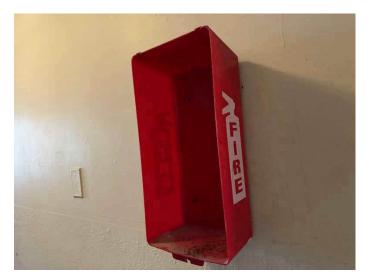
Building 2109 missing fire extinguisher. 85.

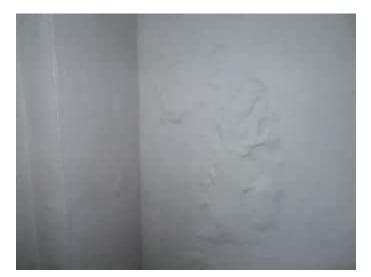
97. Water-damaged wall finishes at dwelling unit.

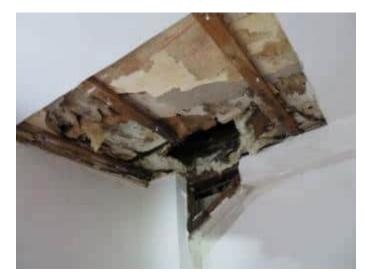
103. Water-damaged ceiling finishes and possible microbial growth.

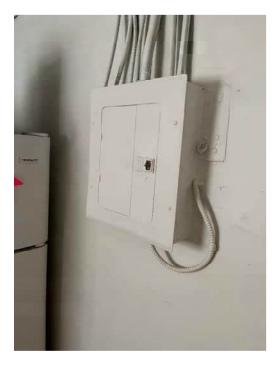
#### FINDING #6 - BUILDING 2107 APARTMENT 32A

The electrical panel in the kitchen was completely painted shut and unopenable. If the resident or maintenance needs to cut power, they may need to use a knife to open the panel door.

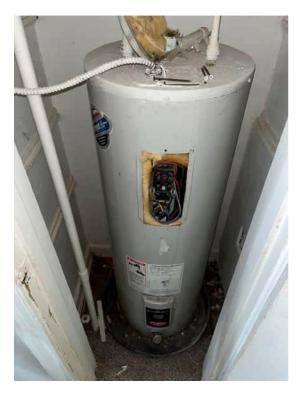
#### FINDING #7 - BUILDING 2107 APARTMENT 32C

The water heater in this unit had caught fire recently. However, all power has been cut off to this unit pending replacement/maintenance.

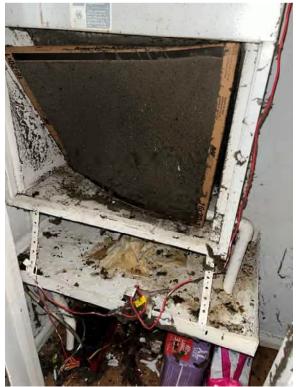
#### FINDING #9 - BUILDING 2109 APARTMENT 41B

This unit was in the worst condition out of all of the units that were observed. There was exposed wiring observed, the air conditioning return was fully clogged, there were missing outlet covers, and the overall condition of the entire apartment was not fit for living.

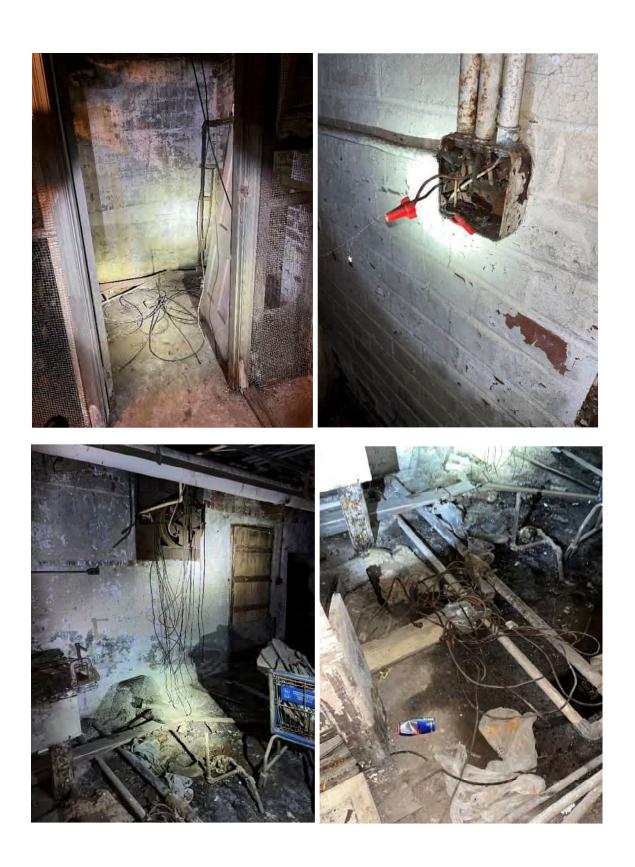
#### FINDING #10 - BASEMENT

There was exposed wiring observed throughout, the emergency lighting "bugeye" fixtures were not operable, and there were outlets completely painted over.

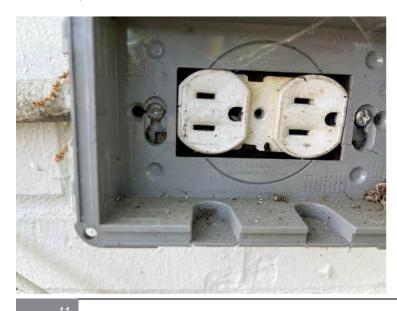
# FINDING #15 – OUTDOOR RECEPTACLE NOT GFCI BEHIND BUILDING 2107

There was an outdoor receptacle that was not ground fault protected. The National Electrical Code (NEC) requires all outdoor receptacles for dwellings to have GFCI protection either upstream of the receptacle or at the receptacle.

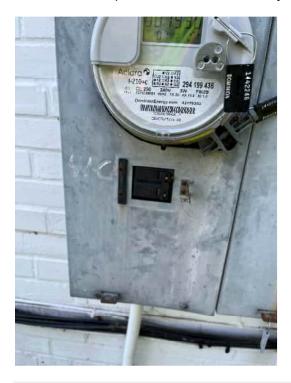
# FINDING #16 – METER BANK MAIN CIRCUIT BREAKER MISSING COVER BEHIND BUILDING 2109

The main circuit breaker for apartment 41C was missing a weatherproof cover. Without this cover moisture and droplets of water can make way into the meter bank and cause a short or serious damage.

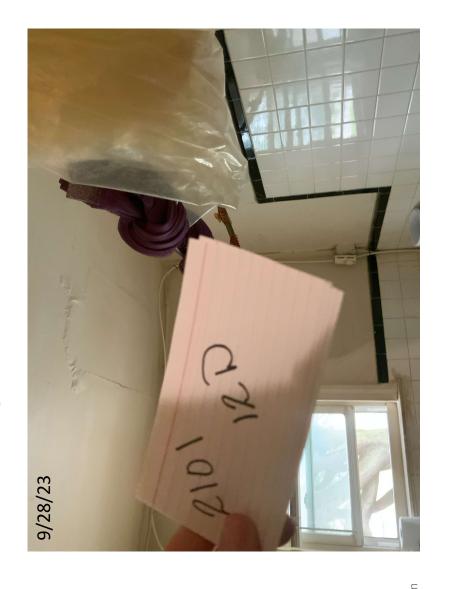
### Ceiling Structure Failure

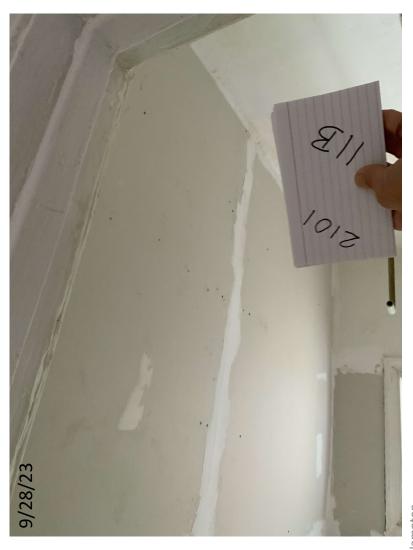
# Recent Repair of Ceiling Collapse

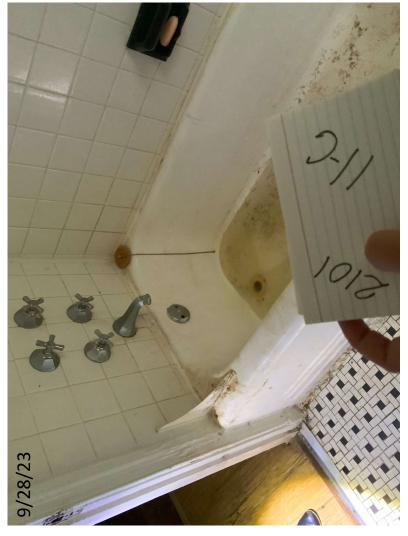
### Plumbing Back-up

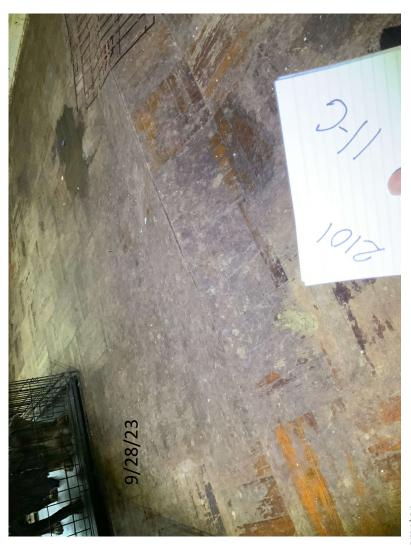
# Floors Deteriorated and Buckling

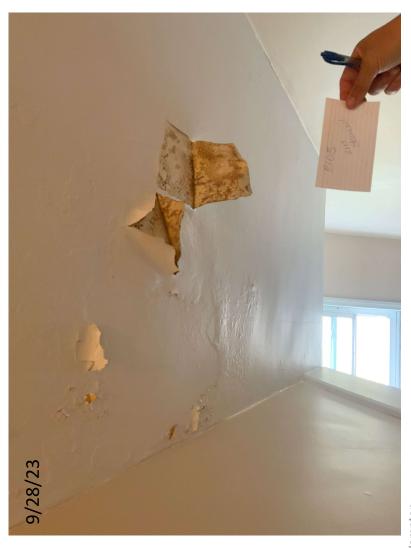
# Water Intrusion in Hallway Ceiling

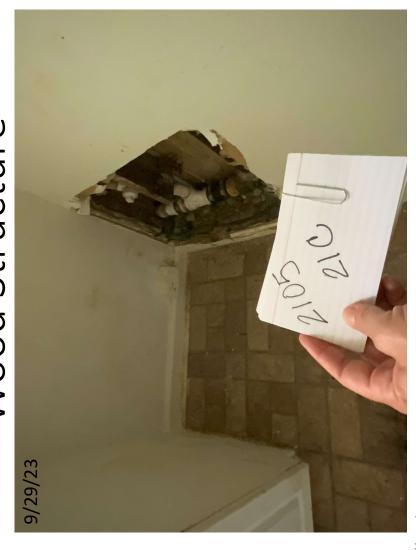
### Plumbing Leak and Surrounding Deteriorated Wood Structure

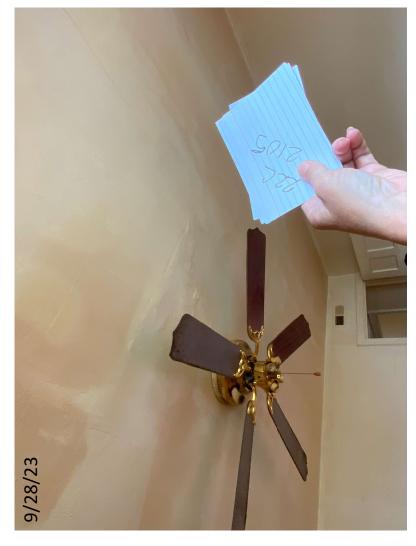
### Ceiling Structure Failure

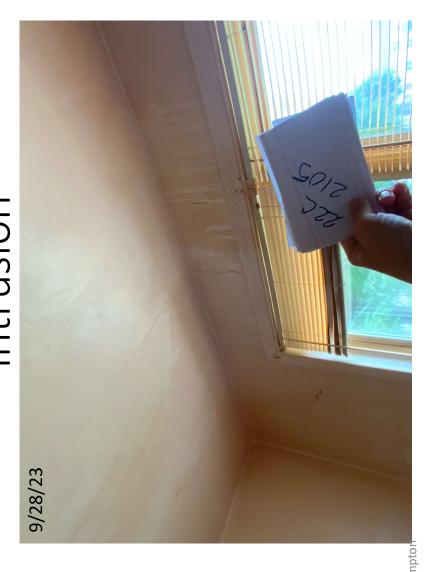
### Cracking in Ceiling and Walls from Water Intrusion

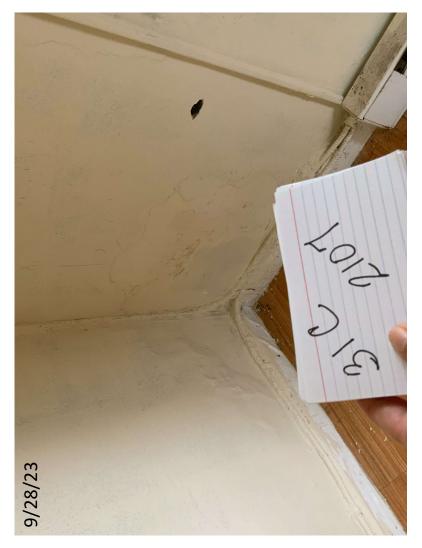
# Walls Soft from Water Intrusion

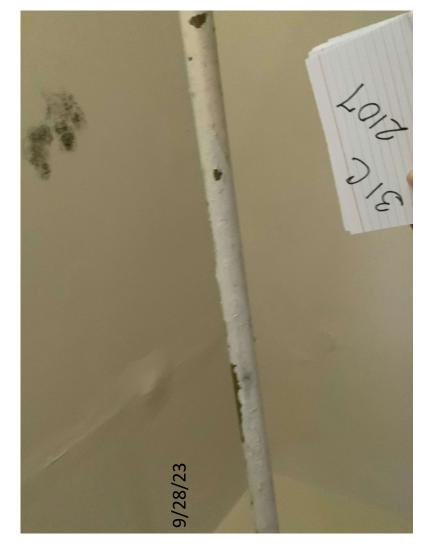
### Ceiling Structure Failure

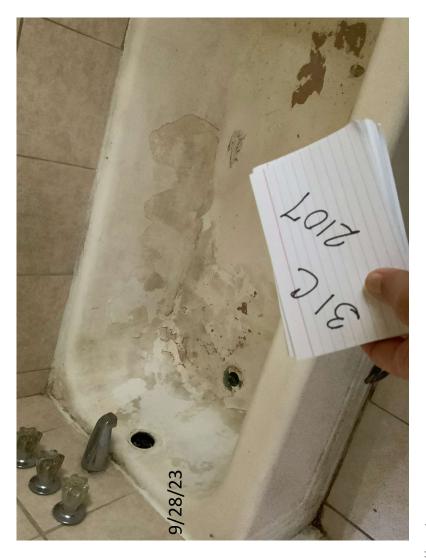
# Deteriorated Plumbing Fixtures

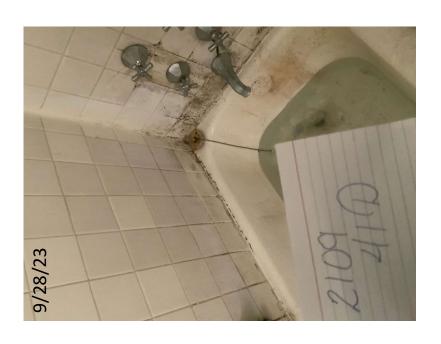
#### Plumbing Back-up

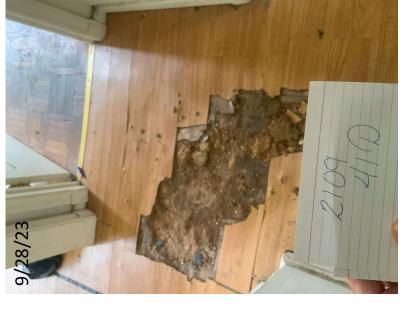
# Floors Deteriorated and Buckling from Water

Intrusion

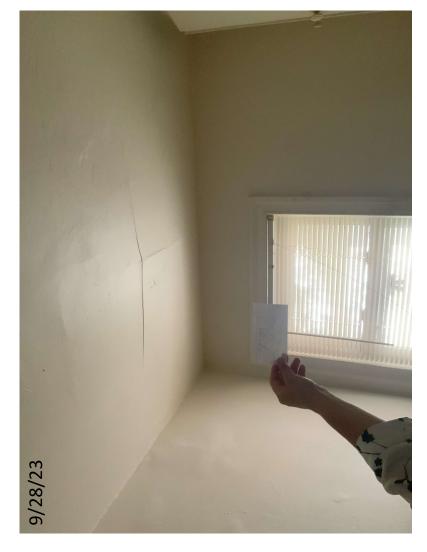
### Ceiling Structure Failure

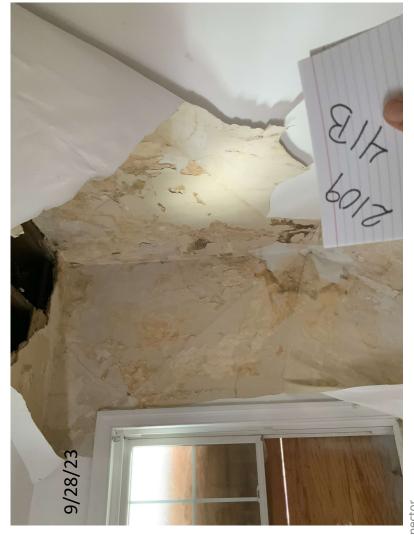
#### Ceiling Collapse

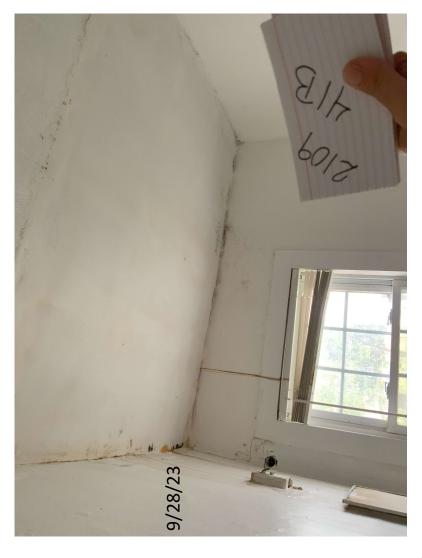
### Ceiling Structure Failure

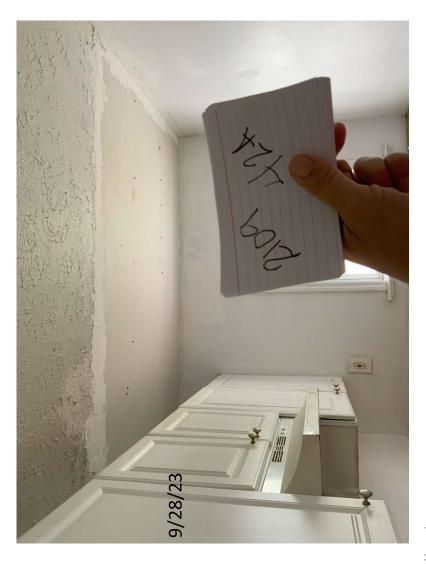
# Recent Repair Due to Ceiling Collapse

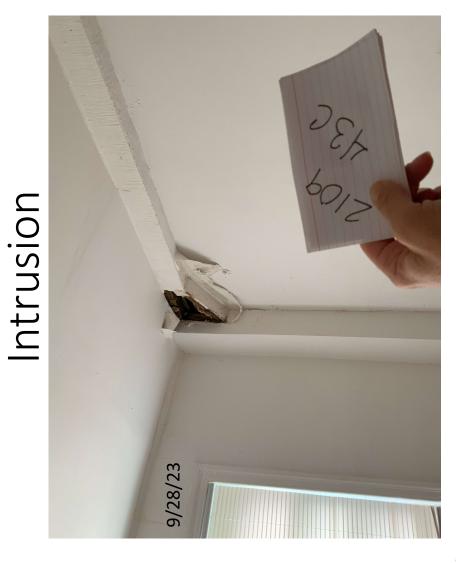
# Interior Wall Structure Failure from Water

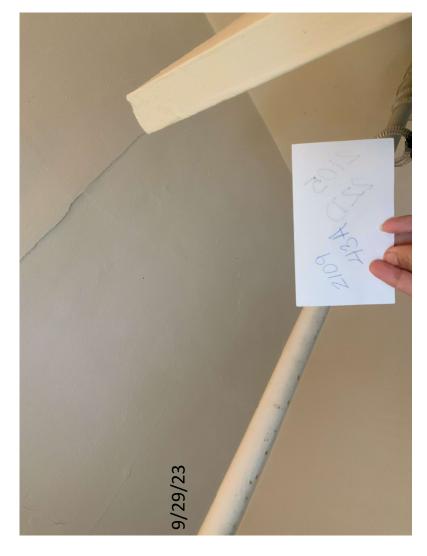
### Ceiling Structure Failure

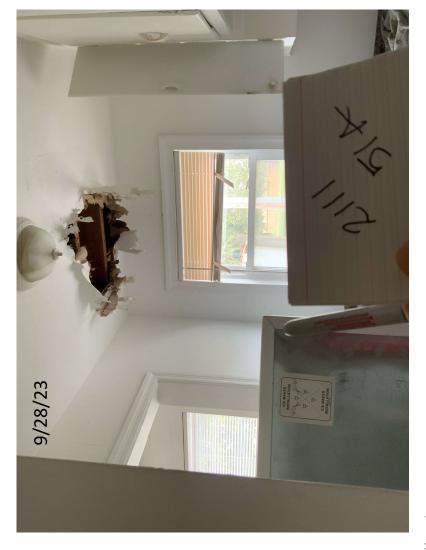
#### Ceiling Collapse

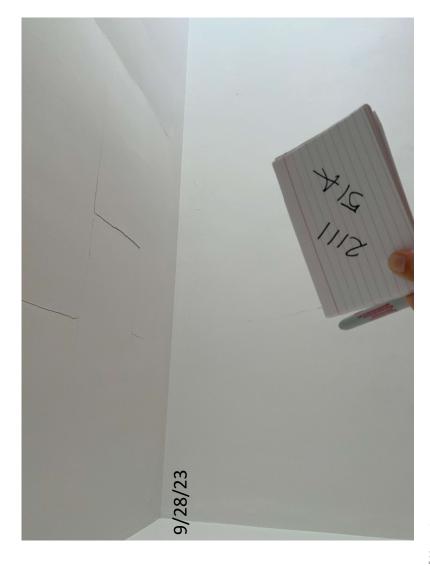
### Ceiling Structure Failing

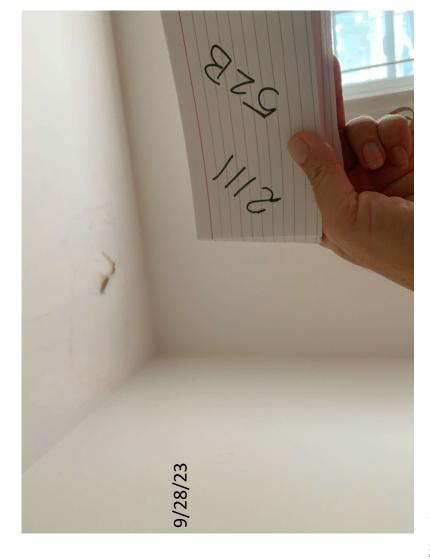
## Ceiling Structure Failing

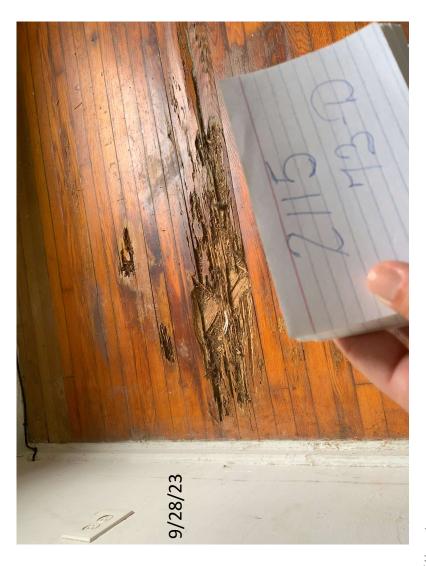
# Floors Deteriorated from Water Intrusion

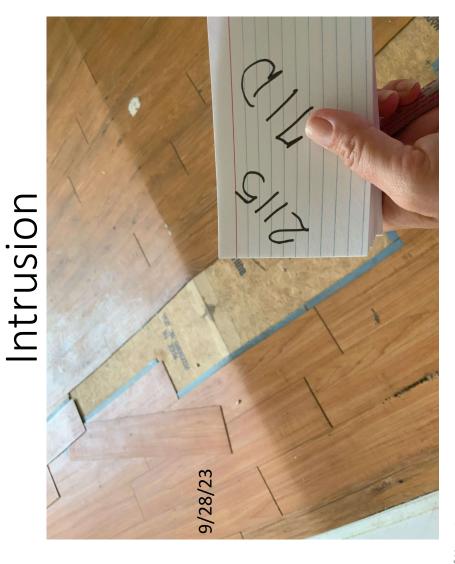
# Floors Deteriorated and Buckling from Water

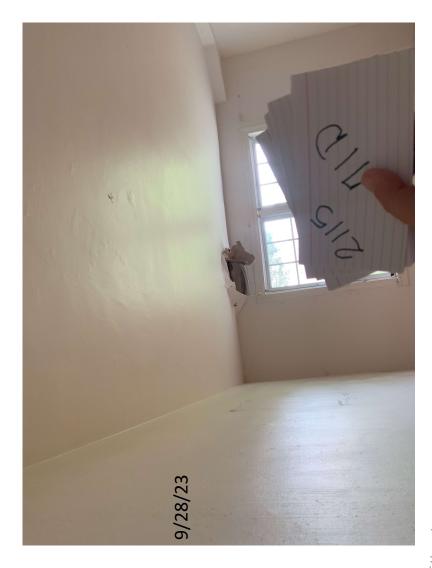
# Ceiling Failing from Water Intrusion

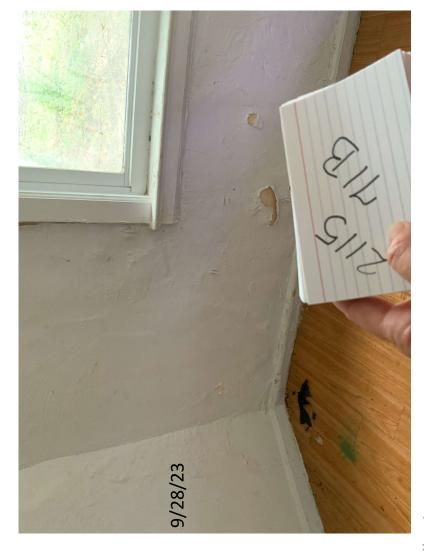
## Walls Soft from Water Intrusion

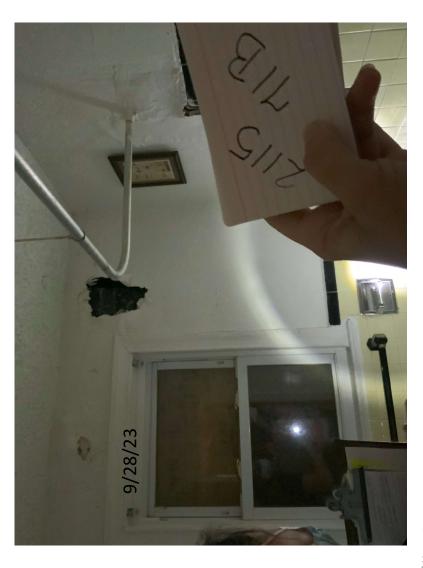
# Wall Structure Failing from Water Intrusion

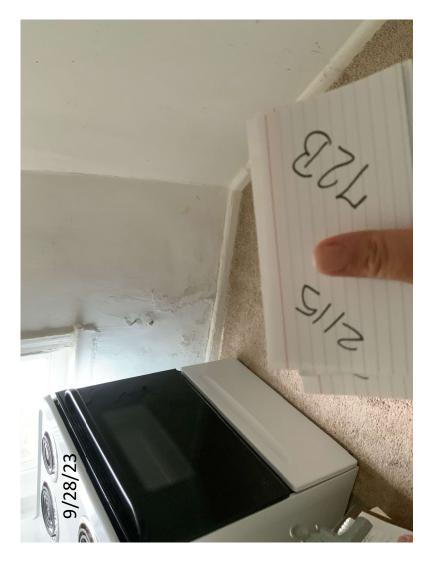
## Walls Soft from Water Intrusion

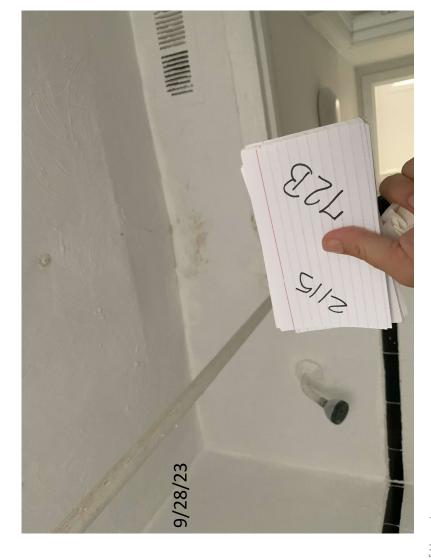
## Ceiling Structure Failing

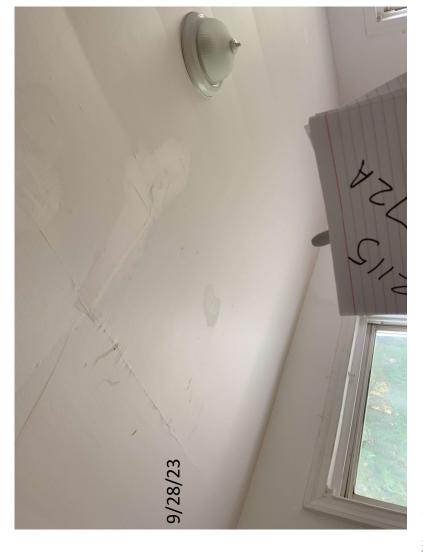
## Ceiling Structure Failing

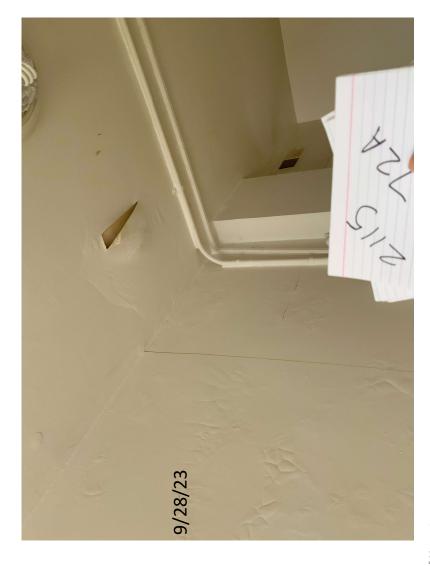
# Wall and Ceiling Structure Failure

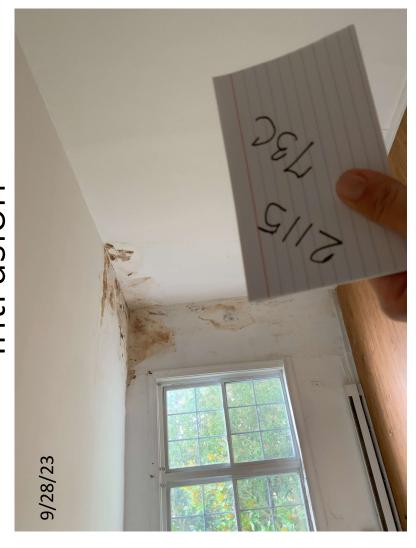
### Wall and Ceiling Failing Due to Water Intrusion

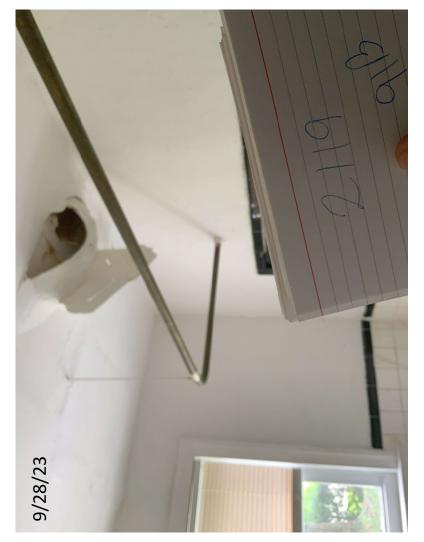
### Ceiling Collapse

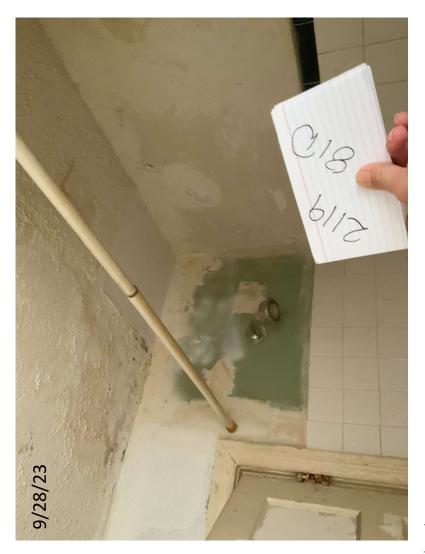
# Water Damaged Ceiling and Walls

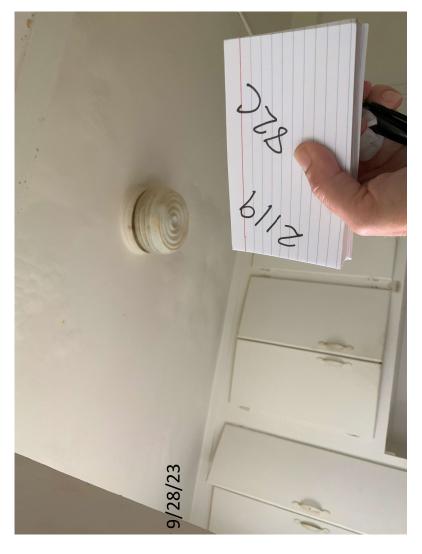
## Ceiling Structure Failing

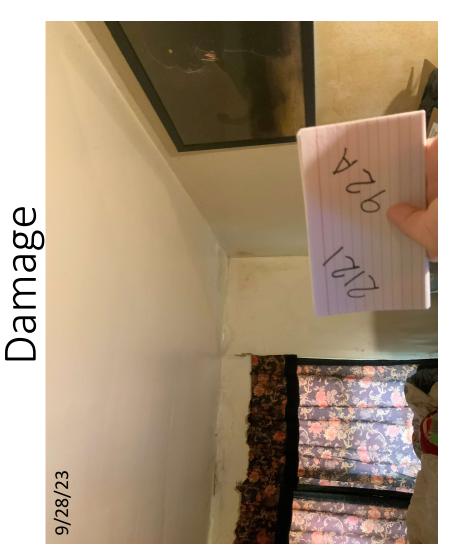
# Ceiling and Walls Deteriorated from Water

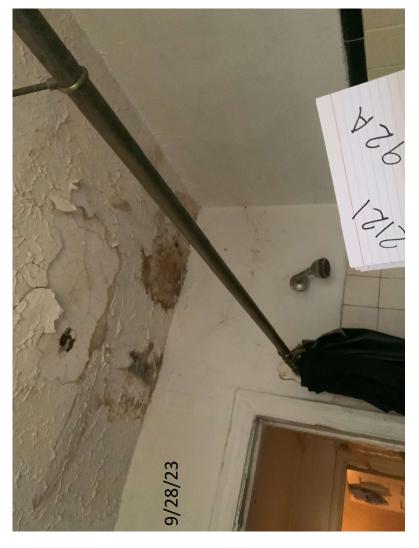
## Ceiling Structure Failing

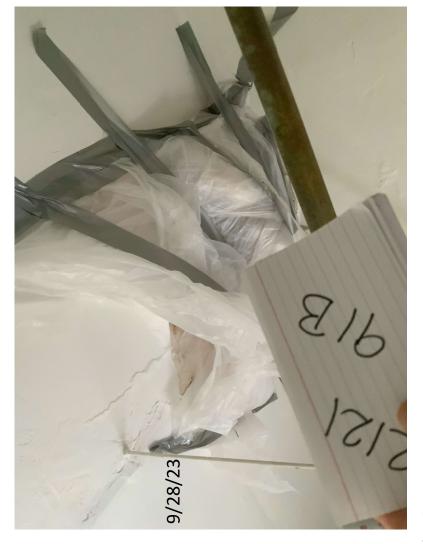
### Ceiling Collapse

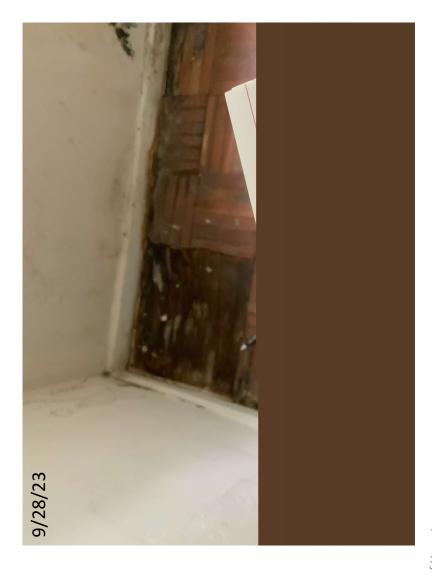
# Floors Deteriorated and Buckling

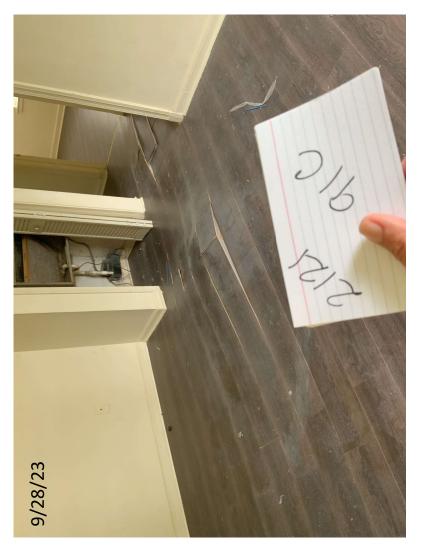
# Floors Deteriorated and Buckling

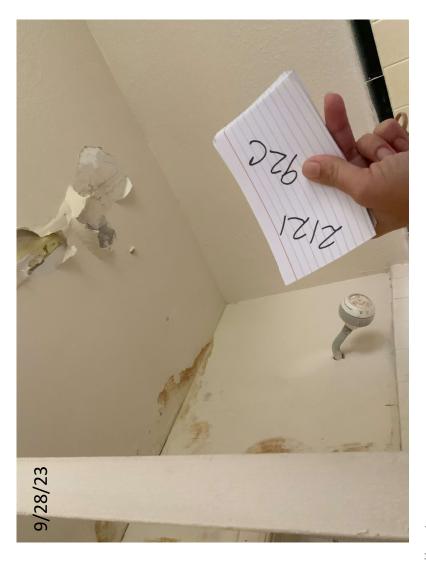
# Ceiling and Wall Structure Failing

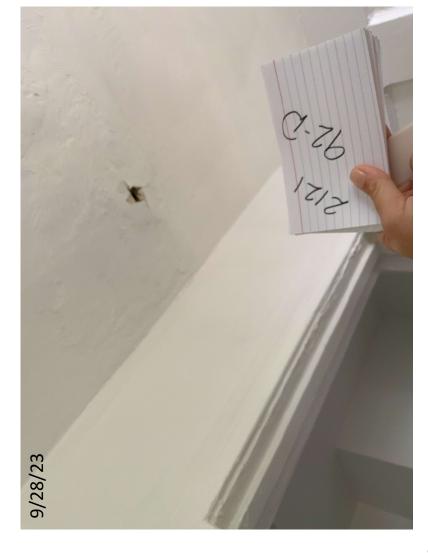
## Ceiling Structure Failing

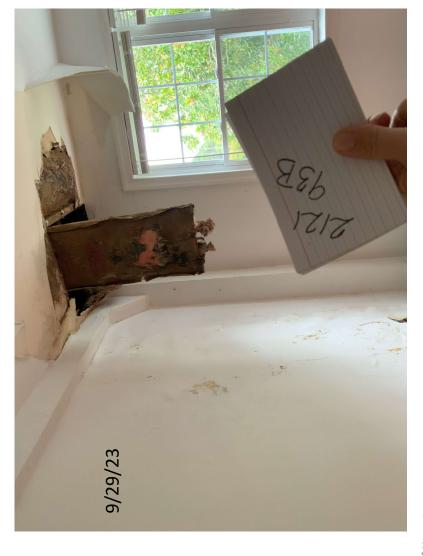
## Ceiling Collapse

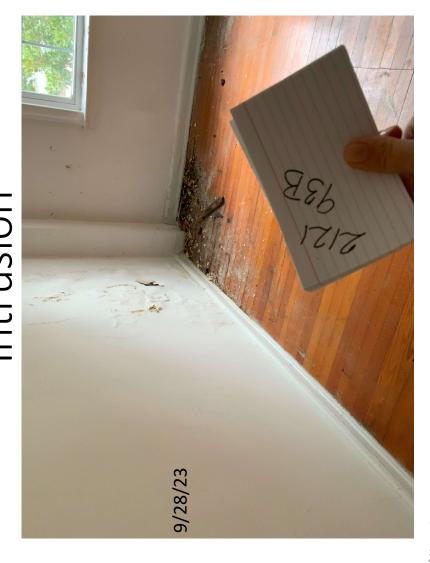
## Walls and Floors Deteriorated from Water Intrusion
