### AGENDA

### STATE BUILDING CODE TECHNICAL REVIEW BOARD

In Re: A10 Capital LLC Appeal No. 24-05

1. On February 20, 2024, the City of Hampton Community Development Department, Property Maintenance and Zoning Enforcement Division (City), the agency responsible for the enforcement of Part III of the 2018 Virginia Uniform Statewide Building Code (VUSBC or VMC), issued a Notice of Violation (NOV) to KRS Holdings (KRS), for the structures located at 2101, 2103, 2105, 2107, 2109, 2111, 2113, 2115, 2117, 2119, and 2121 Kecoughtan Road, in the City of Hampton, for unsafe structure or structure unfit for human occupancy citing VMC Section 106.1 Unsafe Structure or Structures Unfit for Human Occupancy and providing the following:

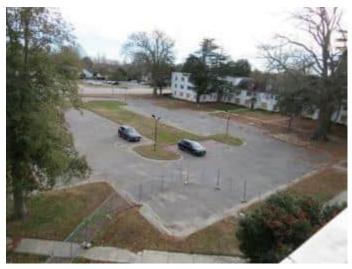
2. Asphalt-paved parking area at the center of the site.

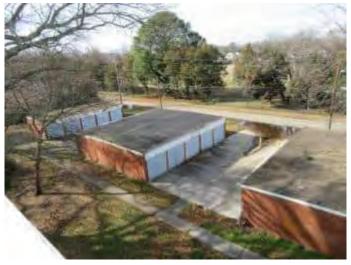
5. Parking garage buildings at the north side of the site (several have been converted to storage).

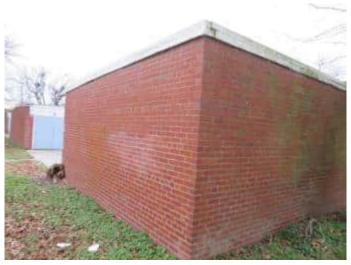
8. Staining at exterior of garage building.

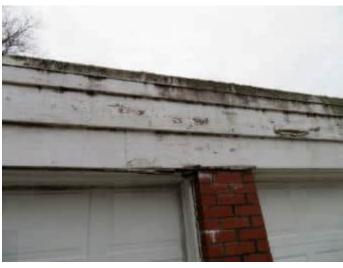
9. Distressed wood and staining at garage exterior.

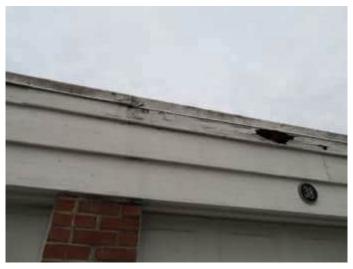
10. Distressed wood at garage exterior.

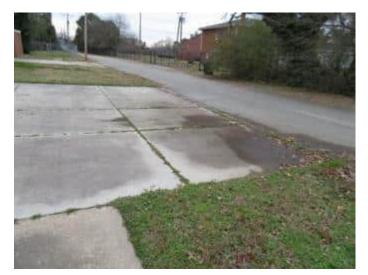
13. Localized distressed concrete pavement at parking garages.

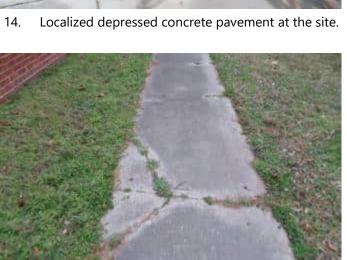
16. Distressed concrete flatwork at the site.

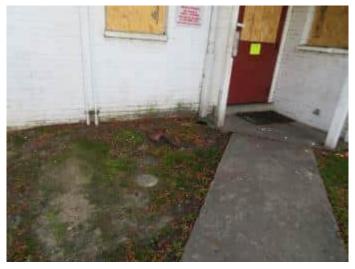
18. Localized area of barren soil at building perimeter.

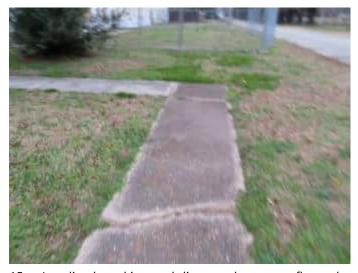
15. Localized cracking and distressed concrete flatwork at the site.

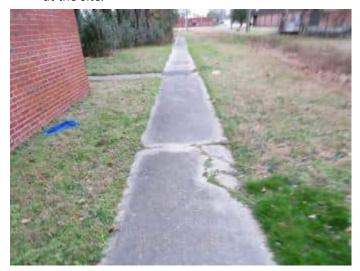
17. Area of concrete flatwork distress at parkin garage areas.

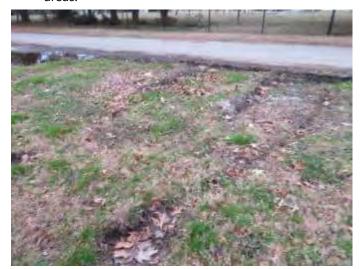
19. Localized erosion at the site.

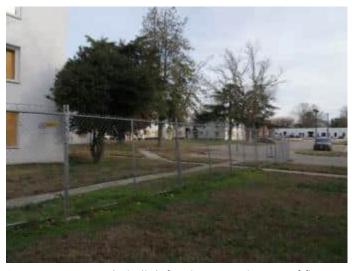
21. Temporary chain link fencing at perimeter of firedamaged building section.

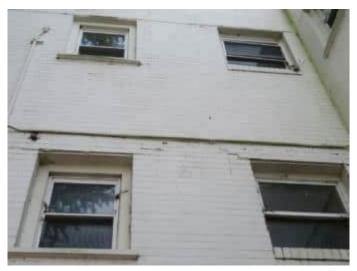
28. Localized step cracking and possible off-plane movement at masonry over window.

- 3. Prune and/or remove large trees that extend over and deposit debris atop roof areas.
- 4. Properly repair and repoint perimeter brick masonry wall cracks and lateral separations where moisture can enter walls and where freeze-thaw damage has occurred. Include replacement of significantly-corroded window opening steel lintels with equal-size hotdipped galvanized steel elements.

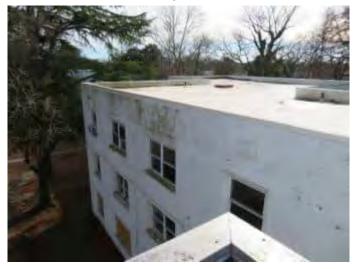
30. Staining at building exterior.

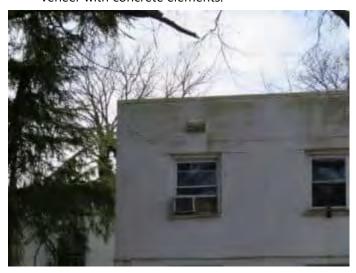
29. Cracking brick at upper portion of the building.

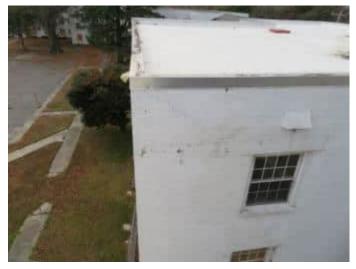
31. Cracking at upper portion of building.

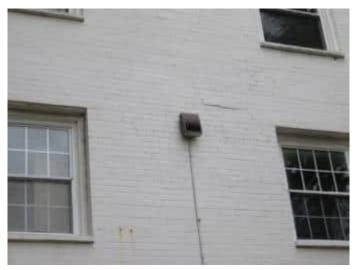
32. Localized cracking and possible off-plane movement.

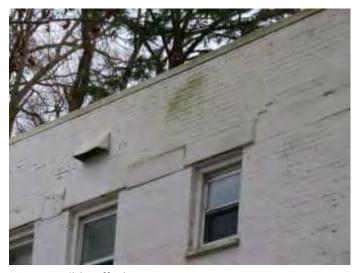
33. Possible off-plane movement at concrete over window.

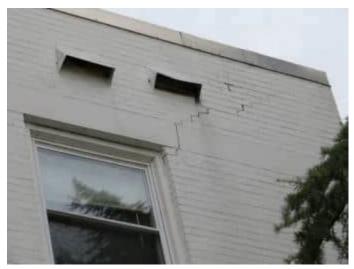
35. Cracking brick and concrete at building upper level.

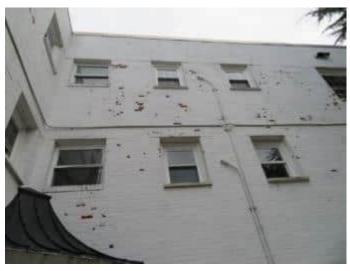
39. Areas of blistered and peeling paint at exterior.

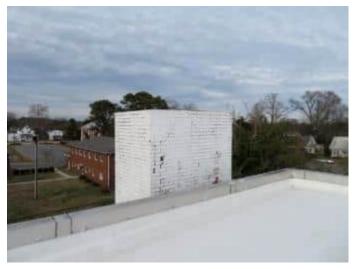
41. Localized step cracking at brick chimney.

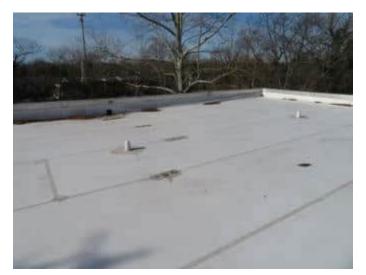
43. Low-sloped TPO membrane roof assembly at apartment building.

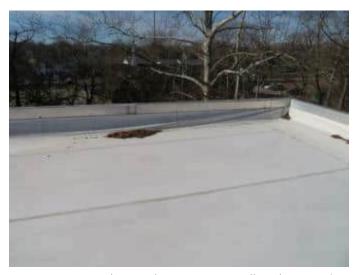
45. Loose membrane along parapet wall and vegetative debris.

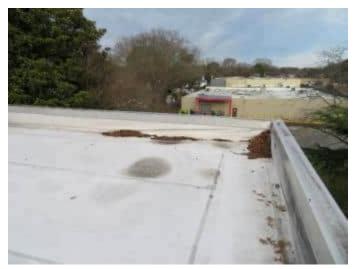
47. Vegetative debris and loose membrane.

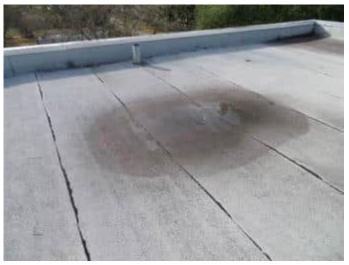
50. Localized area of possible ponding at built-up roof assembly.

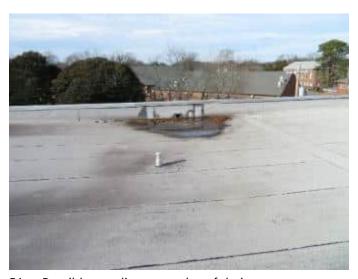
51. Possible ponding around roof drain.

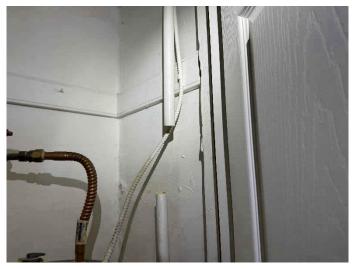
64. Missing piping in DHW heater closet.

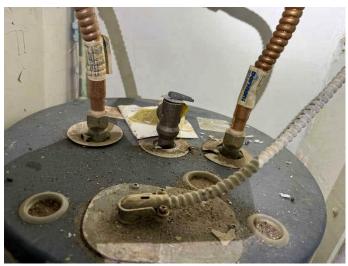
65. DHW heater missing safety release valve piping.

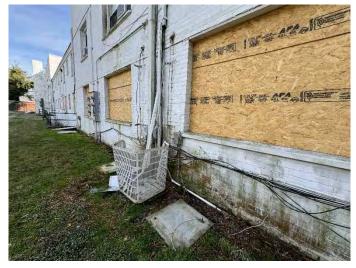
66. AC condenser unit removed from slab.

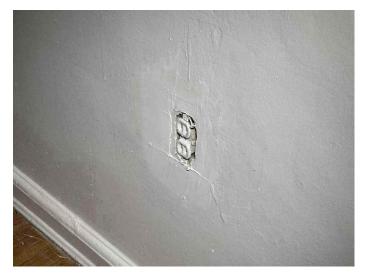
Missing electrical outlet cover.

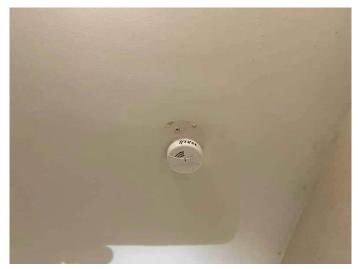
Common area corridor smoke detector. 86.

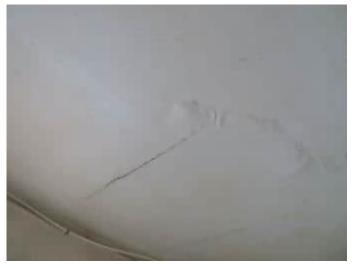
96. Water-damaged ceiling finishes at dwelling unit.

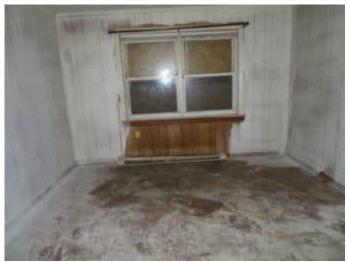
100. Possible microbial growth at dwelling unit.

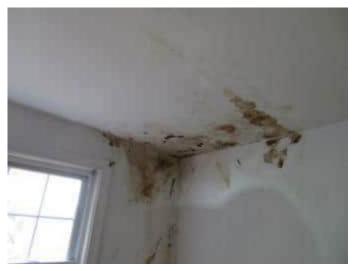
104. Water-damaged ceiling finishes and possible microbial growth.

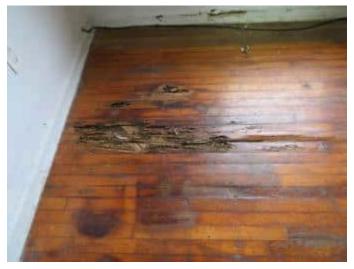
105. Distressed wood flooring.

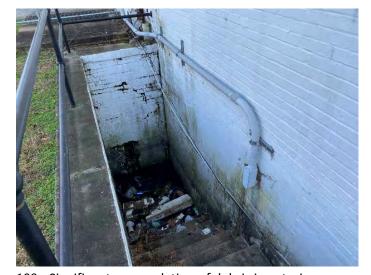
109. Significant accumulation of debris in exterior stairwells leading to basement at Building 2111.

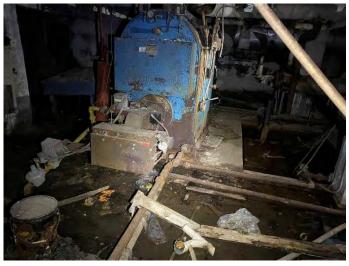
110. Debris on the basement floor interfering with drainage to sumps and standing water in sumps.

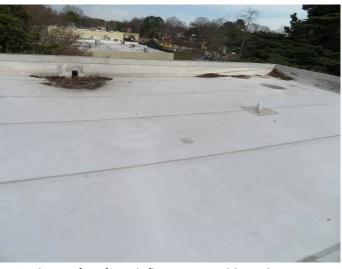
111. The roof surface deflects noticeably in the vicinity of the easternmost corner of Building 2115.

- 3. The missing smoke detectors/fire alarms shall be remedied per the Fire Marshall's direction.
- 4. Portions of the roof decking at 2115 appear to no longer meet their structural purposes. No one other than an expert in roof repair shall access this roof until deemed safe by the roof repair expert. This portion of the roof is not the same portion of the roof with the clogged drain.

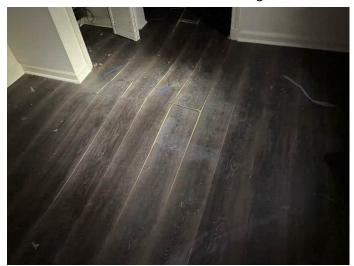
113. Finish flooring in many units exhibit areas where flooring is uneven or buckled and arching upward.

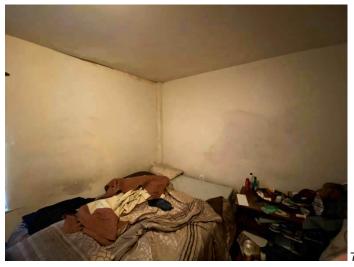
Several units exhibit evidence of unsanitary living conditions. The above are the worst cases observed; the author is unable to determine the extent of these conditions. Evidence of wall and ceiling damage is also present in above right.

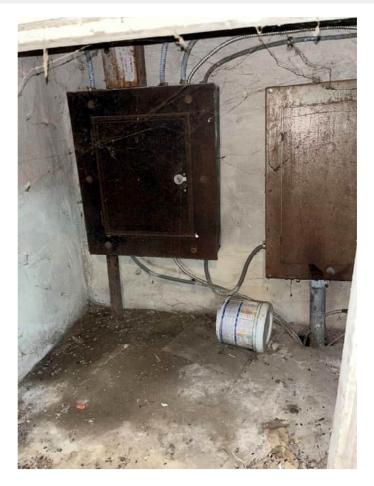
#### FINDING #1 - BUILDING 2101

The main "house" panels that feed building hallway lighting and miscellaneous "house" power are in an extremely hard to reach area underneath the stairwell. Maintenance on these panels is difficult, because the electrician has to be in a crouched position to access the equipment. The maintenance manager explained that only some of these panels are currently in use.

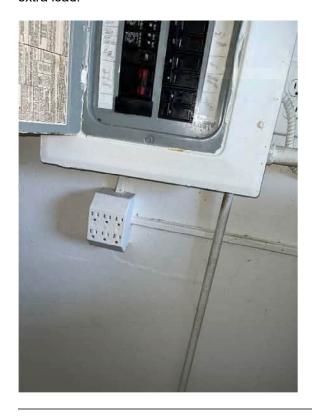
FINDING #11 - BUILDING 2111 APARTMENT 52B

There was a 6-outlet extender permanently mounted to the wall where these installations are typically "splitters" and not permanently mounted. This can be dangerous if the circuit is not rated for this type of extra load.

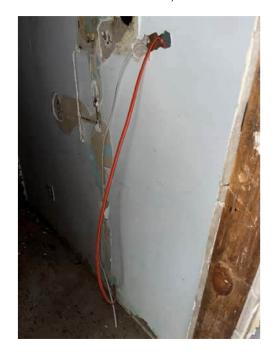
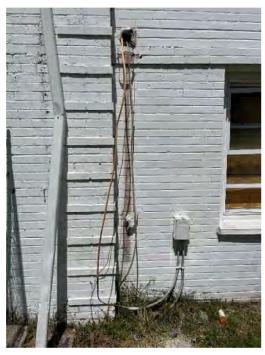
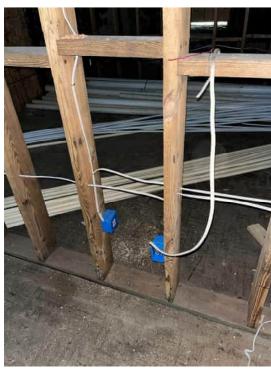
#### FINDING #12 - BUILDING 2113

There was a fire in Building 2113 in 2020. It was discovered there was all new electrical "roughed-in" for the units that are being renovated after the fire, but there was no evidence of an electrical permit for the work. There also appeared to be an extension cord coming from the basement house power through a hole in the wall to an exterior disconnect. The cord appears to have been spliced, run through a few feet of conduit to the disconnect, then rewired to the disconnect.

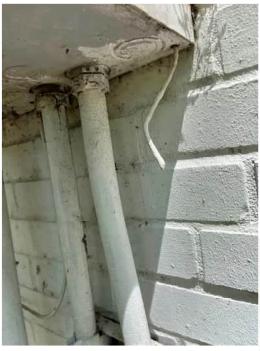
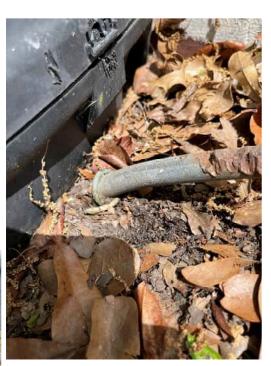
# FINDING #13 – ALL BUILDINGS - SERVICE GROUNDING ELECTRODE CONDUCTOR

The most consequential finding of the visit to Colonial Landing was the lack of grounding electrode conductors (bare copper but in this case it has been painted) from the incoming utility service. By code, at the service disconnecting means, there must be a grounding electrode conductor connected to a grounding electrode (ground rod, building steel, water pipe, etc.). For the main equipment feeding all the apartment units, most of the meter banks appeared to have the main service grounding electrode conductor cut and the ground rod missing. There was approximately one meter bank that was new and had a service ground (see below for reference of proper grounding) and one older meter bank with a disconnected ground rod. This missing component may not seem to affect the electrical system. However, it creates a great hazard for fire in the case of lightning, for example. If lightning were to strike the building, the enormous amounts of electricity would have no path to earth to dissipate and would therefore travel an unintended path through the electrical system and building that could create conditions for fire.

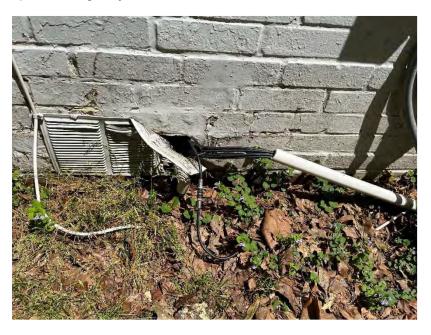
# FINDING #14 – WIRES RUNNING THROUGH AIR VENT/CONDENSATE DRAIN BEHIND BUILDING 2105

There appeared to be multiple wires running through an air vent that also had a condensate drain running through it. Without properly sealing this penetration for the conduit and wires, the crawl space was left open to foreign objects such as animals, insects, etc.

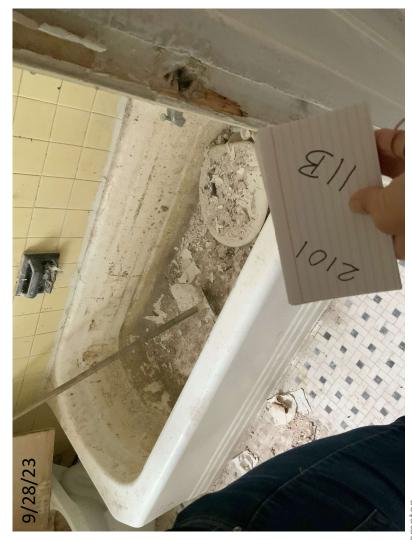
9/28/23 Photo taken by City of Hampton inspector Megan Lands - Virginia Maintenance Code Section 106.1

## Ceiling Collapse in Bathroom

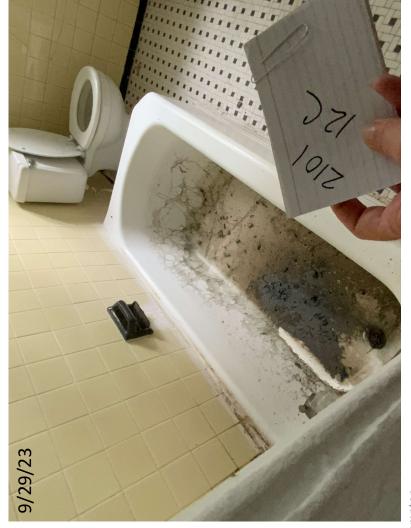
9/28/23 Photo taken by City of Hampton inspector Megan Lands - Virginia Maintenance Code Section 106.1

### Plumbing Back-up

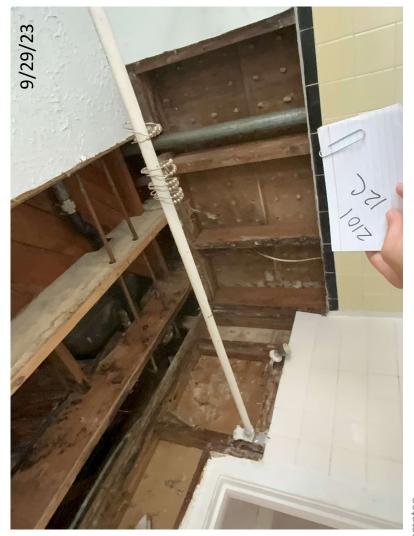
9/29/23 Photo taken by City of Hampton inspector Megan Lands - Virginia Maintenance Code Section 106.1

#### Ceiling Collapse

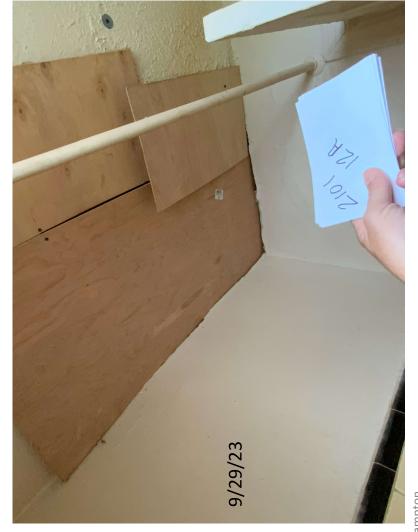
9/29/23 Photo taken by City of Hampton inspector Megan Lands - Virginia Maintenance Code Section 106.1

#### Ceiling Collapse

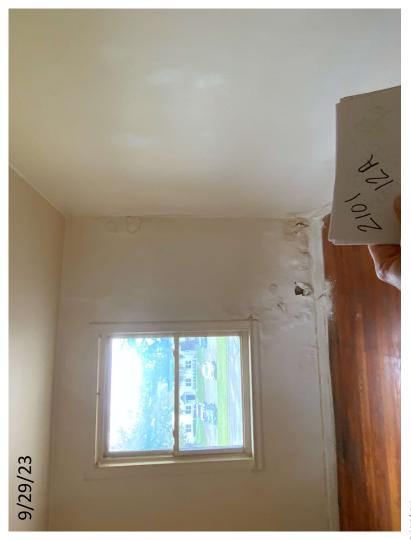
9/29/23 Photo taken by City of Hampton inspector Megan Lands - Virginia Maintenance Code Section 106.1

# Walls Soft from Water Intrusion

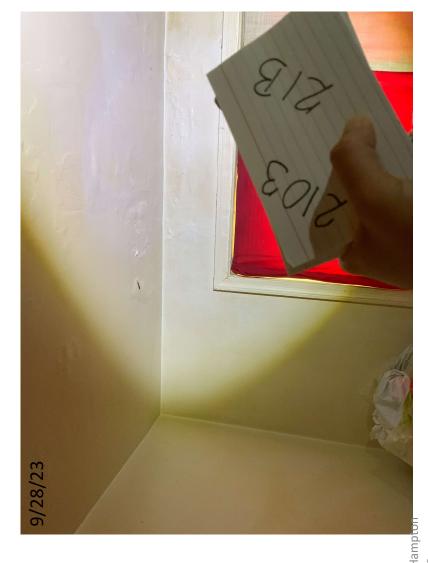
9/28/23 Photo taken by City of Hampton inspector Megan Lands - Virginia Maintenance Code Section 106.1

# Water Intrusion in Ceilings and Walls

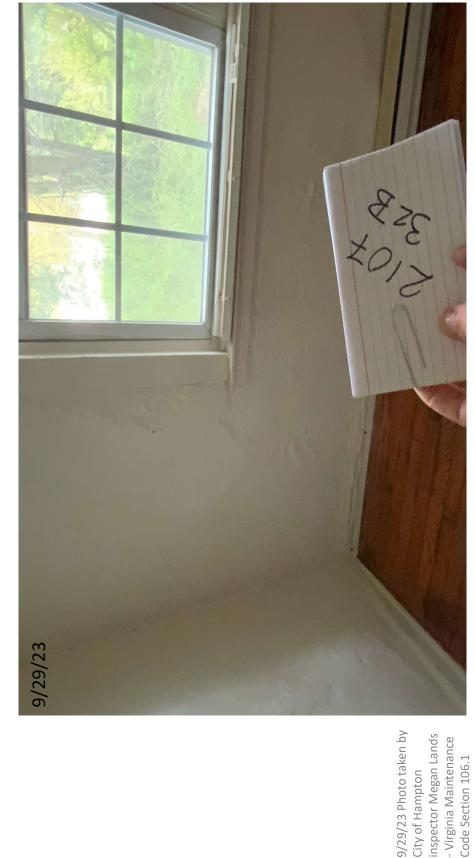
9/28/23 Photo taken by City of Hampton inspector Megan Lands - Virginia Maintenance Code Section 106.1

# Walls Soft from Water Intrusion

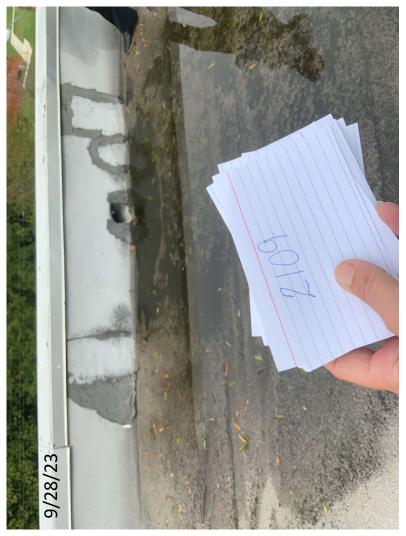
9/28/23 Photo taken by City of Hampton inspector Megan Lands - Virginia Maintenance Code Section 106.1

#### Flat Roof Ponding

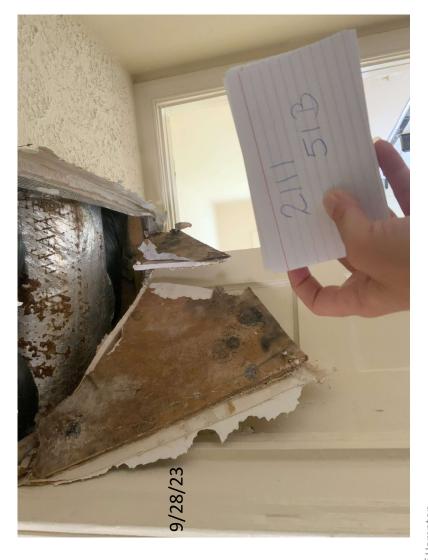
9/29/23 Photo taken by City of Hampton inspector Megan Lands - Virginia Maintenance Code Section 106.1

#### Ceiling Collapse

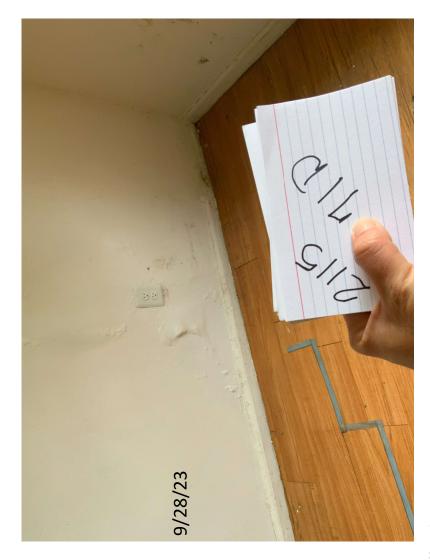
9/28/23 Photo taken by City of Hampton inspector Megan Lands - Virginia Maintenance Code Section 106.1

## Walls Soft from Water Intrusion

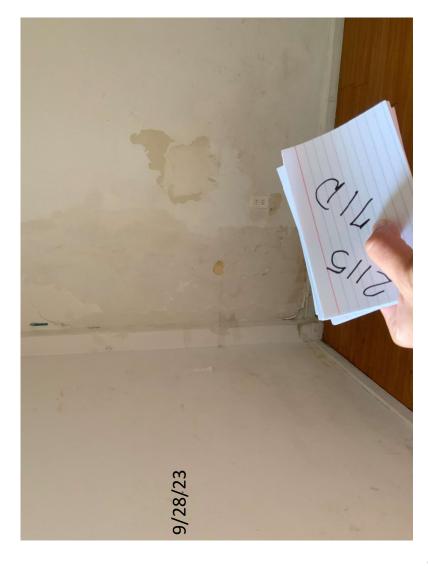
9/28/23 Photo taken by City of Hampton inspector Megan Lands - Virginia Maintenance Code Section 106.1

## Walls Soft from Water Intrusion

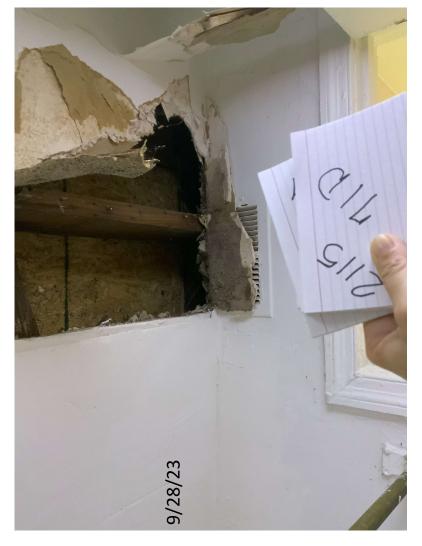
9/28/23 Photo taken by City of Hampton inspector Megan Lands - Virginia Maintenance Code Section 106.1

### Ceiling Collapse

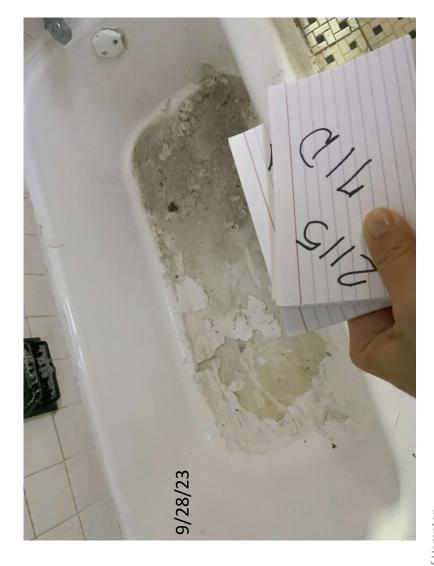
9/28/23 Photo taken by City of Hampton inspector Megan Lands - Virginia Maintenance Code Section 106.1

# Plumbing Fixtures not Maintained

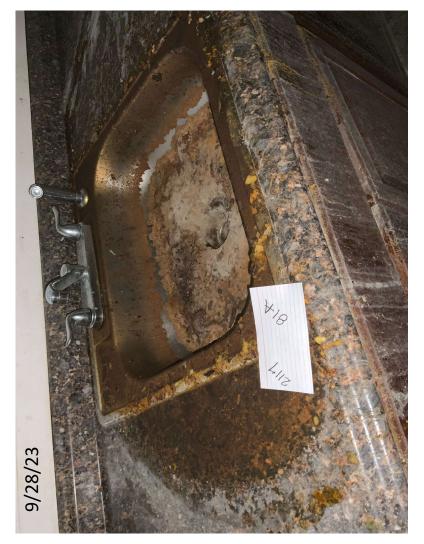
9/28/23 Photo taken by City of Hampton inspector Megan Lands - Virginia Maintenance Code Section 106.1

## Plumbing Back-up
